Condition Survey

Model: 38 ZX Daytona

Manufacturer: Donzi

Vessel Name: Mistifier

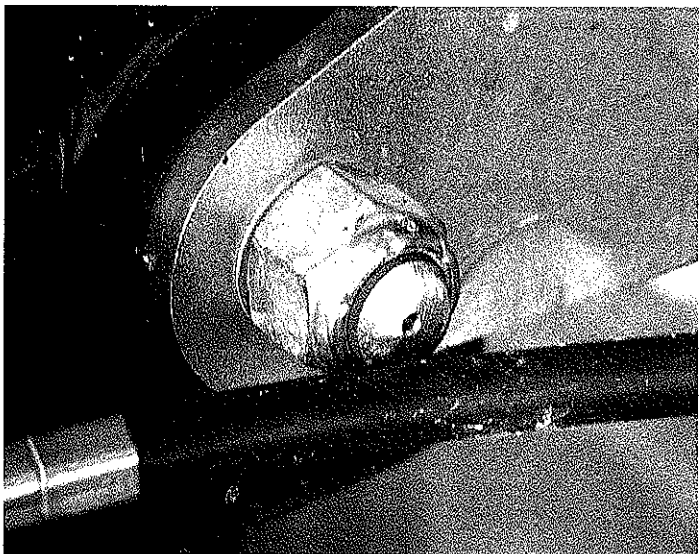
Photo No: 06

Modified outdrive trim indicator cables so they would not chafe on bolts (see pictures # 6, 7, & 8)

Comments: Trim Tab Indicator

Cable at STBD Outdrive

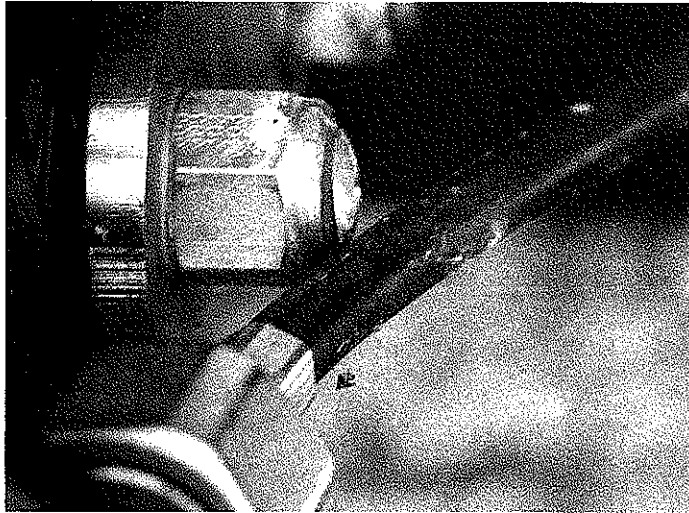
Photo No: 07

Comments: Outdrive Trim

Indicator Cable at STBD

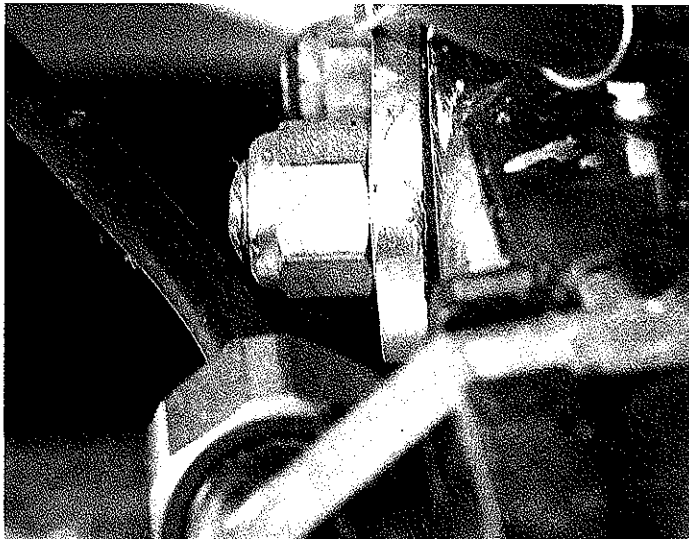
Photo No: 08

Comments: Outdrive Trim

Indicator Cable at Port

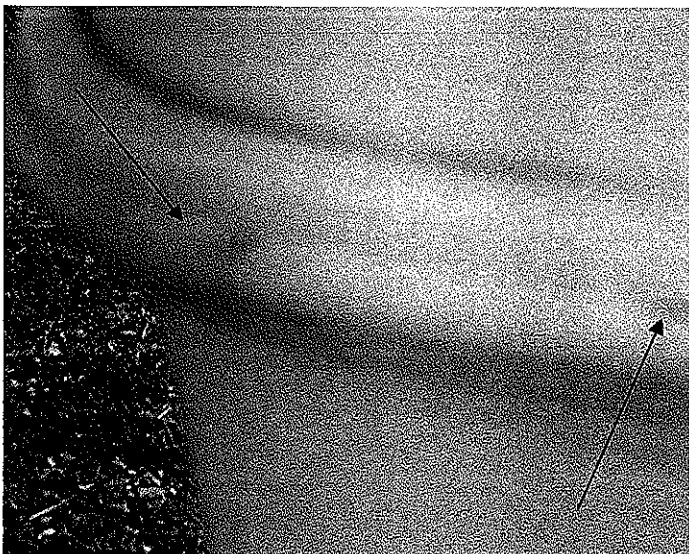
Photo No: 09

Slight rub rail damage on STBD stern at corner

**Comments: Rub Rail Damage at
STBD Stern Corner**

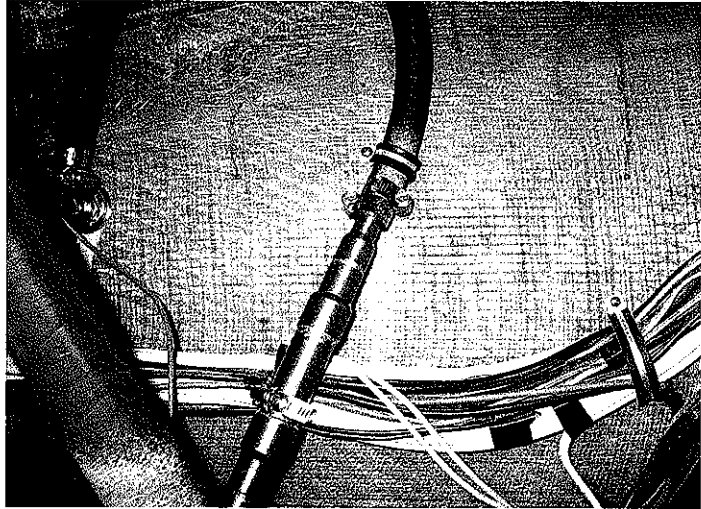
Photo No: 10

Invented and installed a gas vent burp valve in the gas vent hose. He reports that the gas will spill from the vent several times during fueling. He believes this to be excessive and an environmental danger and safety hazard.

Comments: Owners Invention

Baffled Gas Vent

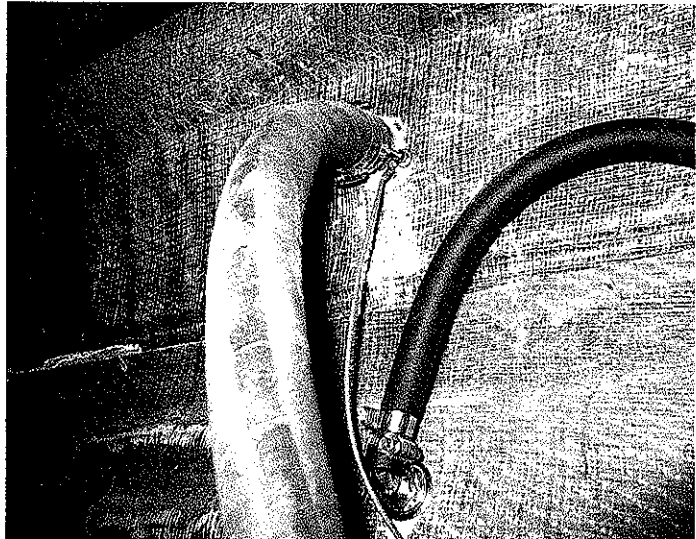
Photo No: 11

This surveyor's opinion is the gas vent thru hull fitting is mounted too low in relationship to the fuel fill causing the excessive gas over flow reported by owner.

**Comments: Inside View of Gas Fill
And Vent**

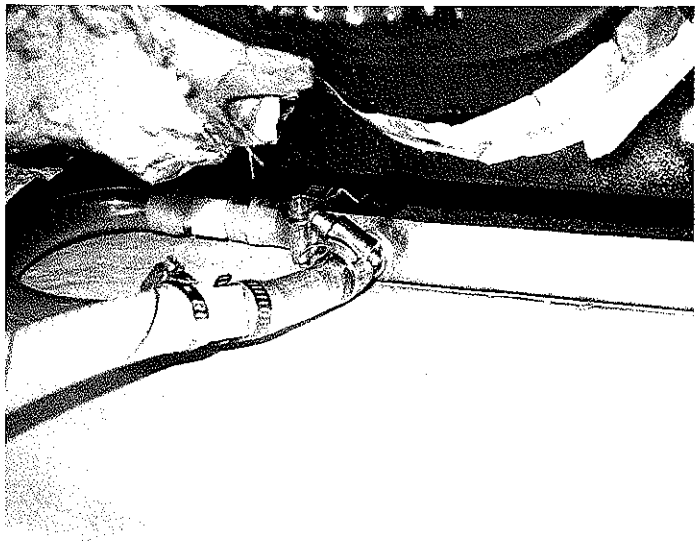
Photo No: 12

Reconfigured air conditioner drain hose and added T-fitting so forward air conditioner drain would drain. Hose was reported to be mounted too high from factory to drain air condition condensation.

**Comments: Owners Revised Air
Conditioning Drain**

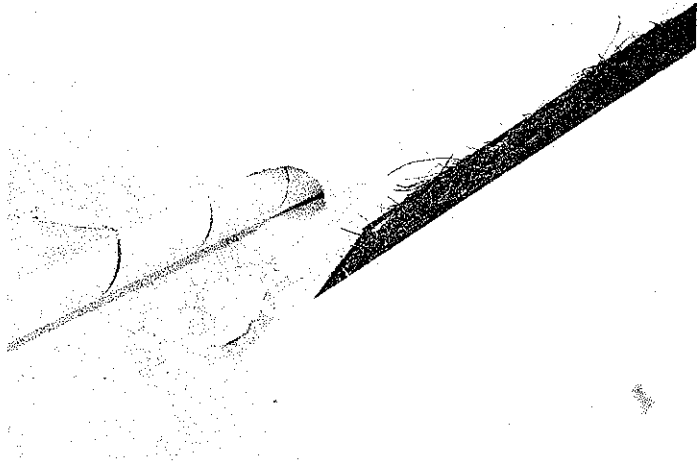
Photo No: 13

**Comments: Access Hole for Air
Conditioning Drain Created by
Owner**

Inspection areas that have been under cabin seating should have rounded corners and a hatch installed. If corners are left squared this area could possibly crack in the future.

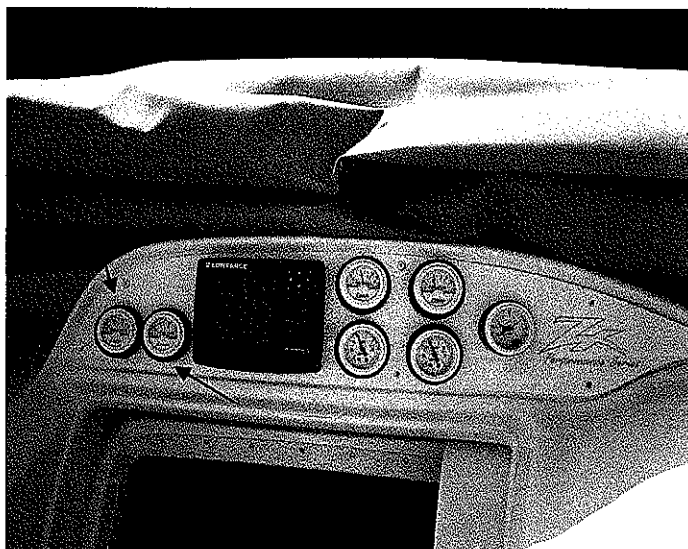
Photo No: 24

Is in the process of installing water pressure gauges.

Comments: Instrument Panel Above

Cabin Entry (note water pressure gauges indicated by arrows were installed by owner)

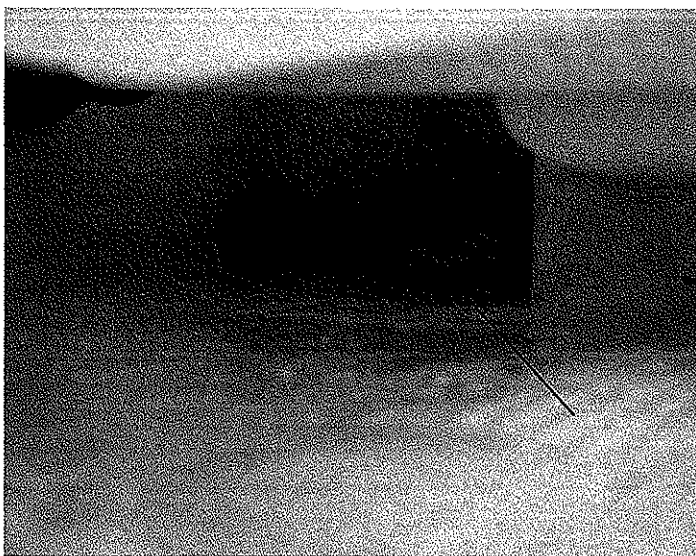
Photo No: 27

Although I viewed the area that Mr. Mertz reported he found human feces, I was unable to establish the evidence of this. Admittedly reported he had cleaned this area. Although some staining of this area existed I could not establish the claim.

Comments: Hull Bottom Area in

**Front of Waste Pump. (where
customer reported finding human
feces)**

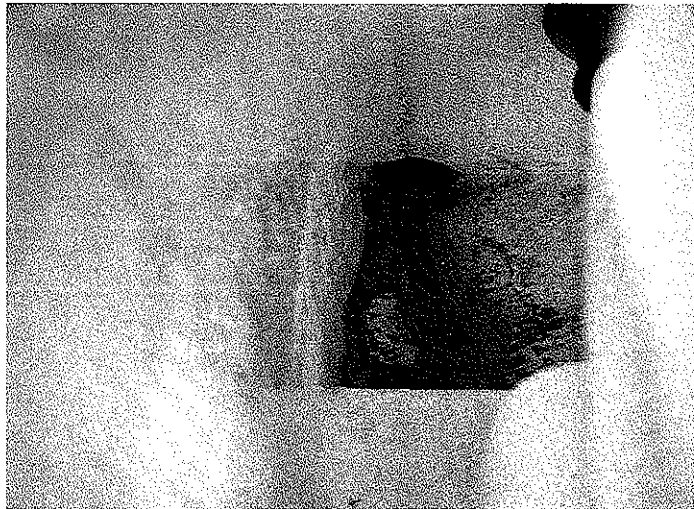
Photo No: 28

Comments: Another View of

Picture #27

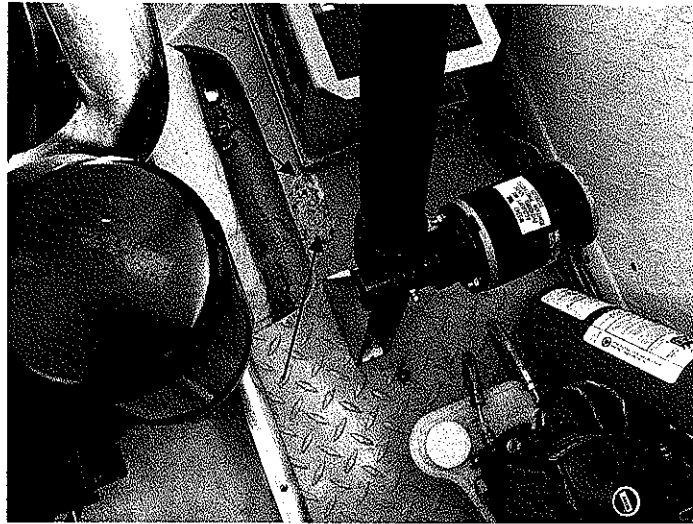
Photo No: 37

Repositioned port hatch lift actuator

**Comments: Port Engine Hatch Lift
(arrows indicate previous mounting
area)**

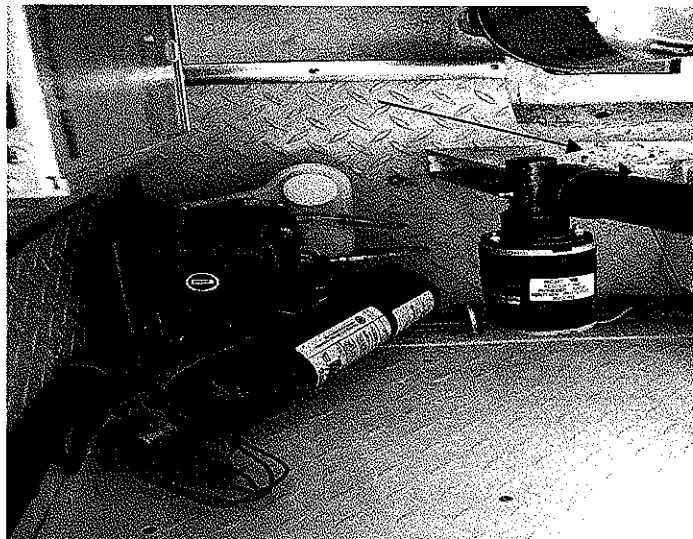
Photo No: 38

**Comments: Different Angle of
Picture #37**

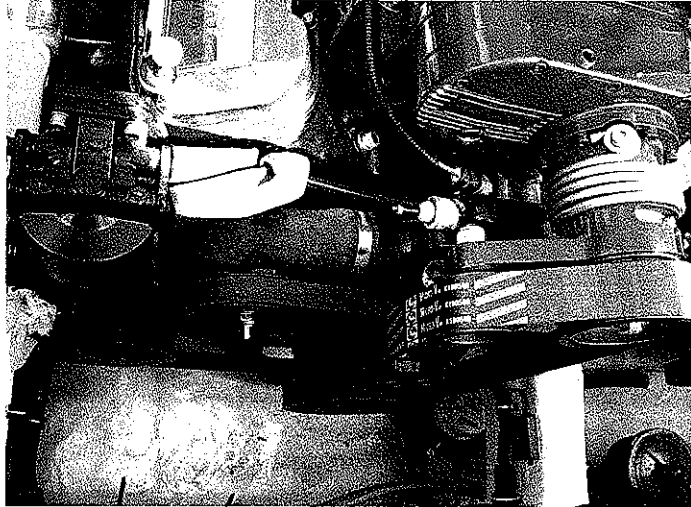
Photo No: 40

An inspection of the engine found the belt had not been removed from the raw water pump. I ask Mr. Mertz why he did not remove the belt. He said he wanted to test the new raw water pump to see what happens while being run dry.

Comments: STBD Engine

Indicating Belts Currently Installed

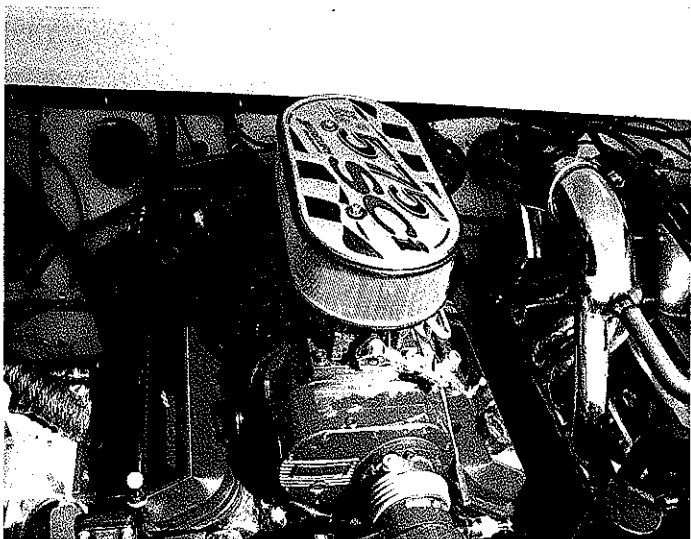
Photo No: 42

STBD Engine has exhaust headers removed

Owner reported the engine overheated while flushing the engines. Although temperature gauge remained at 120 degrees. He reported that the engine started smoking and when he touched the headers they felt like they were 3 or 4 hundred degrees. When shutting down engine he heard a cracking noise, like heat expansion of metal.

After reviewing Mr. Mertz modifications and repairs, it appears that most items have been resolved. Although the possible cracked engine block or cylinder head have not been addressed. Until a proper inspection is completed of the engine, it is impossible to address what repairs need to be made. The assumed problem could be as minor as a head gasket or as severe as a cracked block. All of which can be remedied.

**Comments: STBD Engine, Headers
Removed**

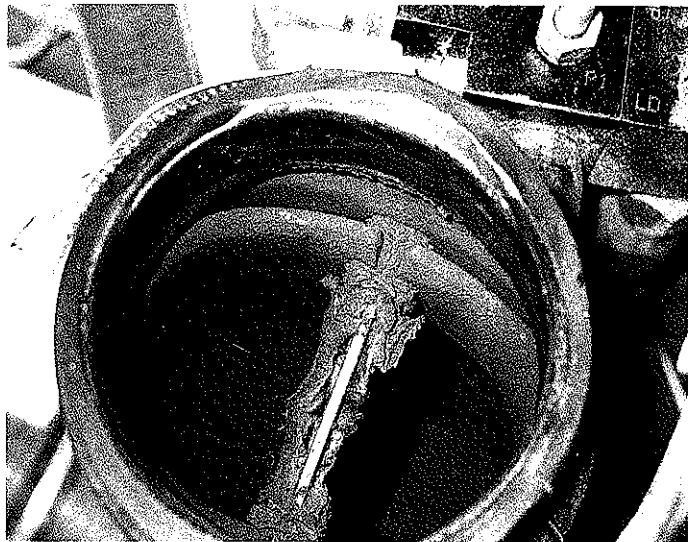
Photo No: 44

pump) is highly unlikely. The STBD engine definitely was over heated, additional proof is the condition of the exhaust flaps, as seen in pictures # 44 and 45.

**Comments: STBD Side STBD
Engine Exhaust**

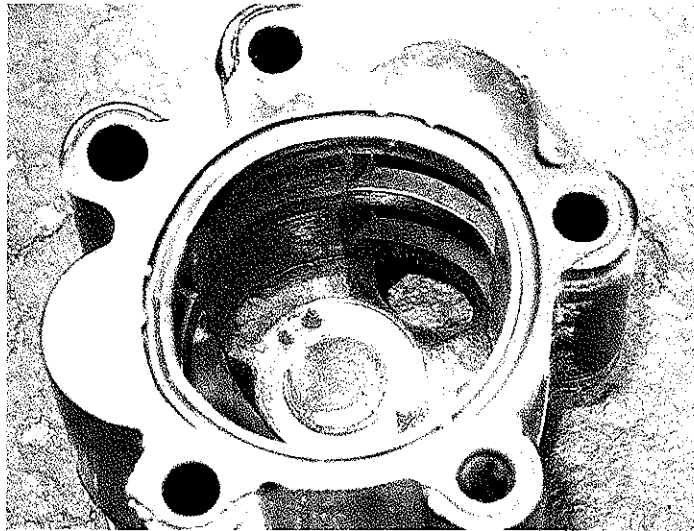
Photo No: 49

The raw water pumps that I viewed were definitely run dry. Normally when this type of water pump is run dry it takes a very short period of time to cause severe damage to the impeller and it's housing. For a water pump to be run dry for a duration of time at an early stage of it's usage and then 30, 40, or 50 hours later deteriorate such as these raw water pumps did (notably the STBD

Comments: STBD Raw Water

Pump Impeller Housing

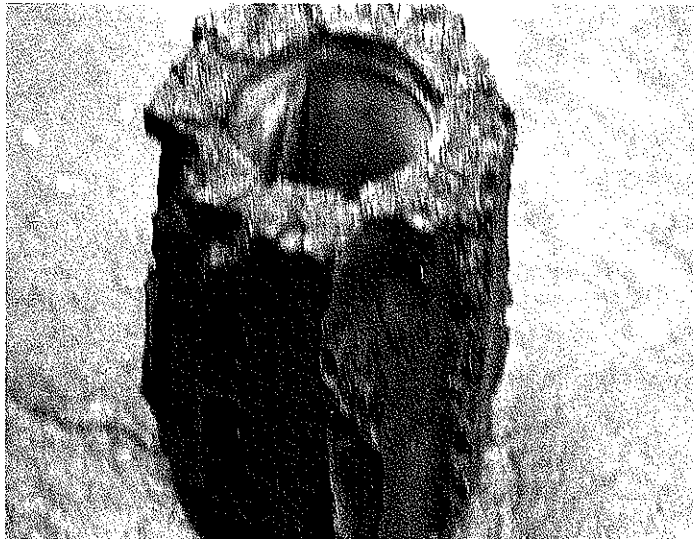
Photo No: 50

Comments: STBD Raw Water Pump

Impeller

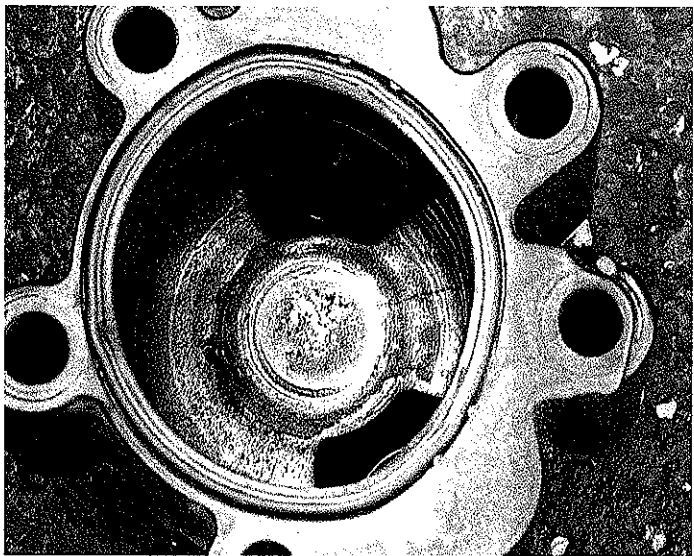
Photo No: 51

Comments: Port Raw Water Pump

Impeller Housing

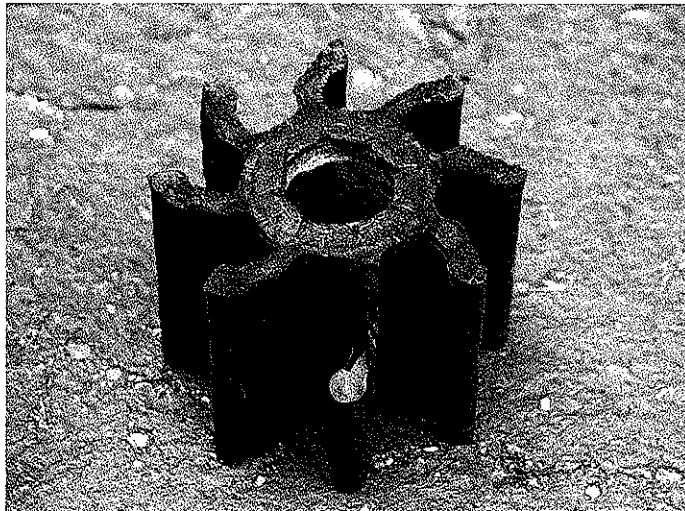
Photo No: 52

Comments: Port Raw Water Pump

Impeller

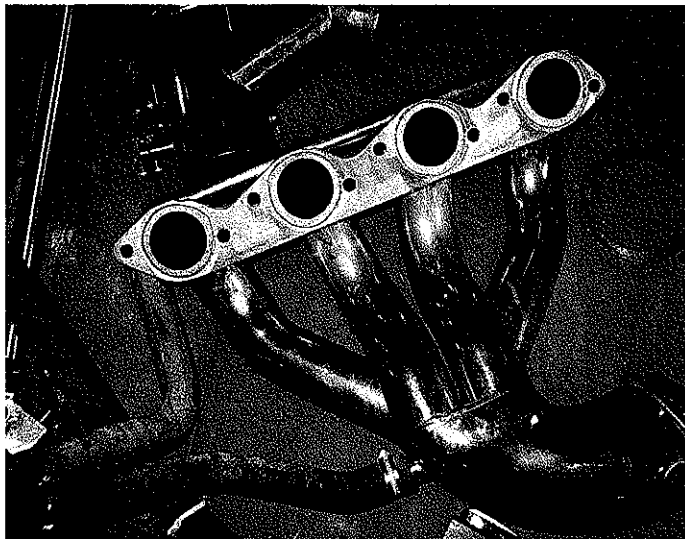
Photo No: 53

Comments: Exhaust Headers for

STBD Engine

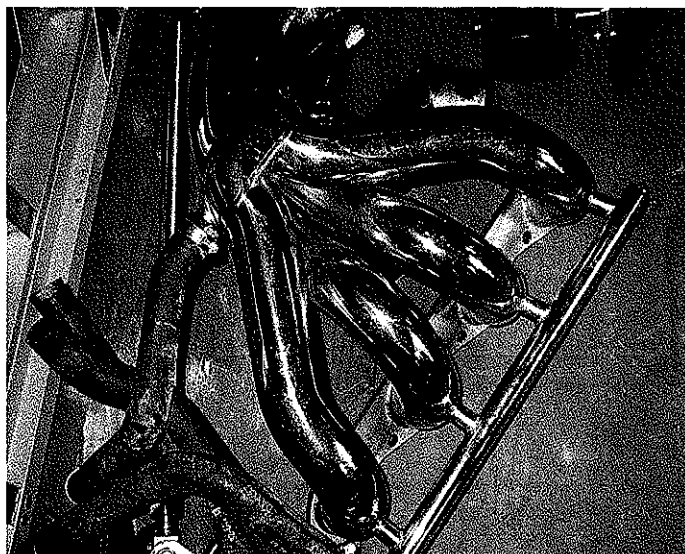
Photo No: 54

Comments: Exhaust Headers for

STBD Engine

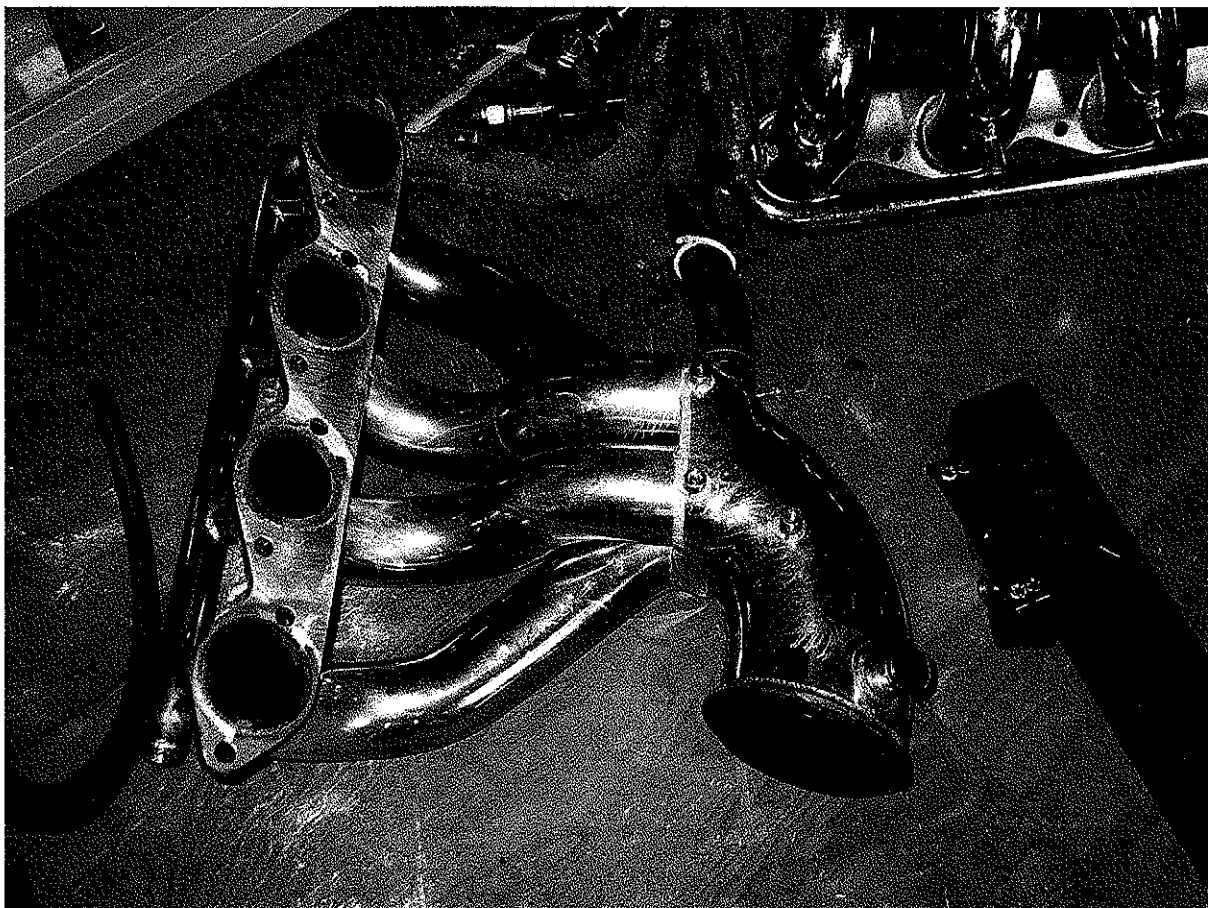
Photo No: 55

**Comments: Exhaust Headers for
STBD Engine**
